Five-Year Review Report
Second Five-Year Review Report
for
Fort Wainwright, Alaska

September 2006

United States Army Environmental Center

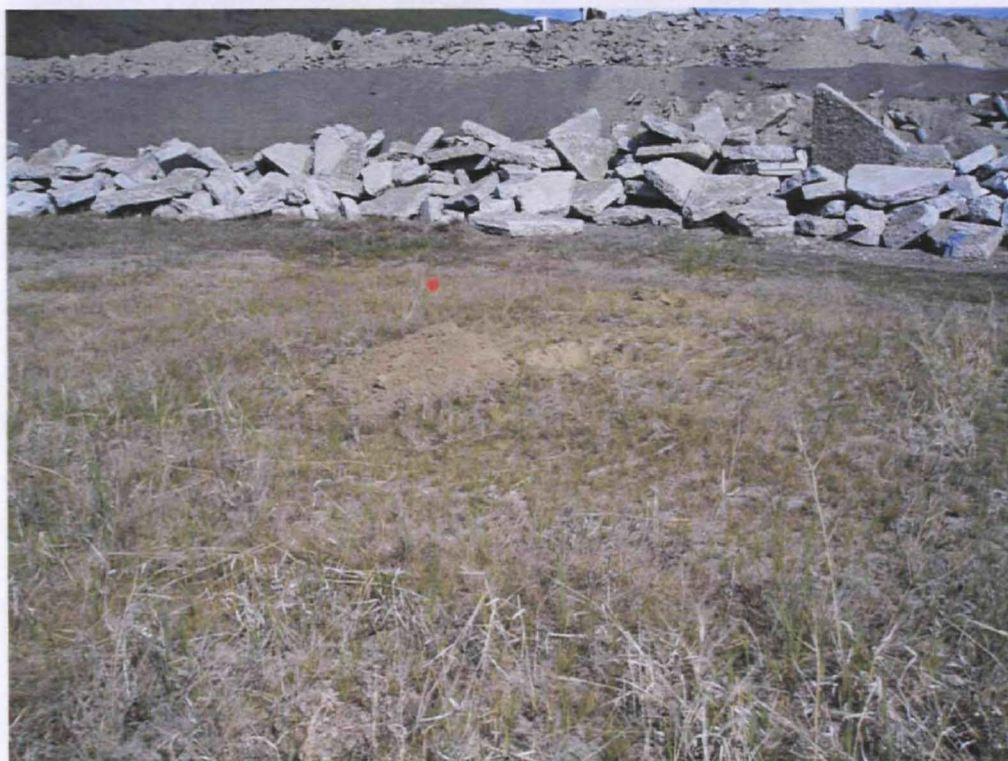
**Photograph 2 – Phytoremediation Cell Showing Concrete Berm
(flag indicates vent location), Operable Unit 1**

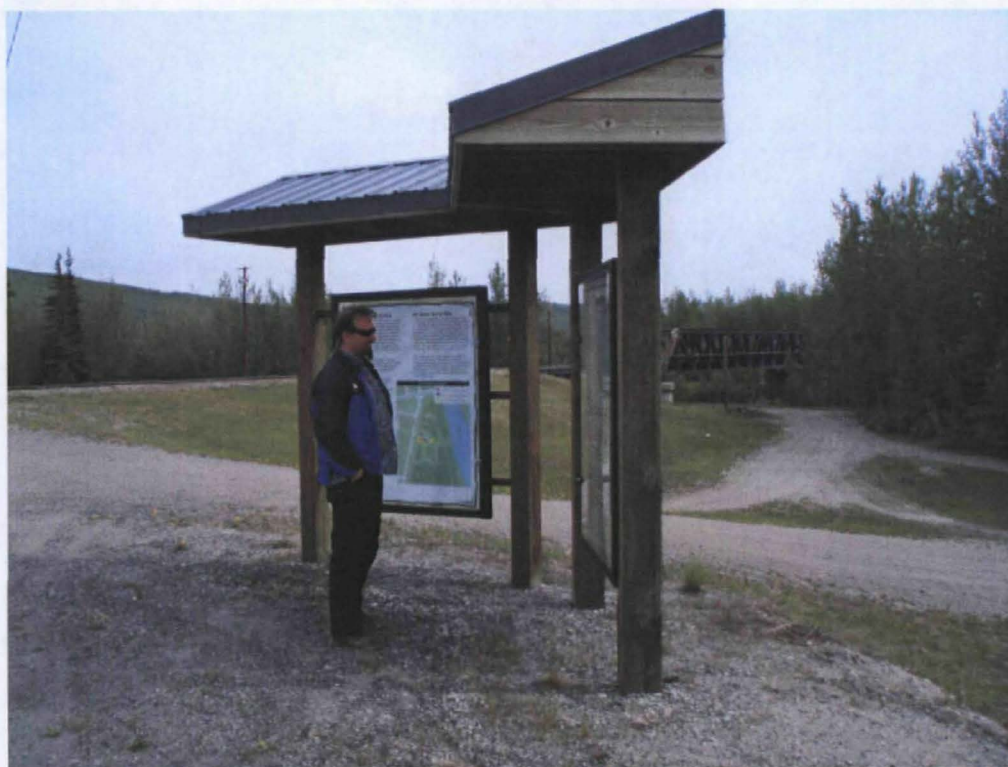
**Photograph 5 – Interpretive Display, 801 Drum Site
Operable Unit 1**

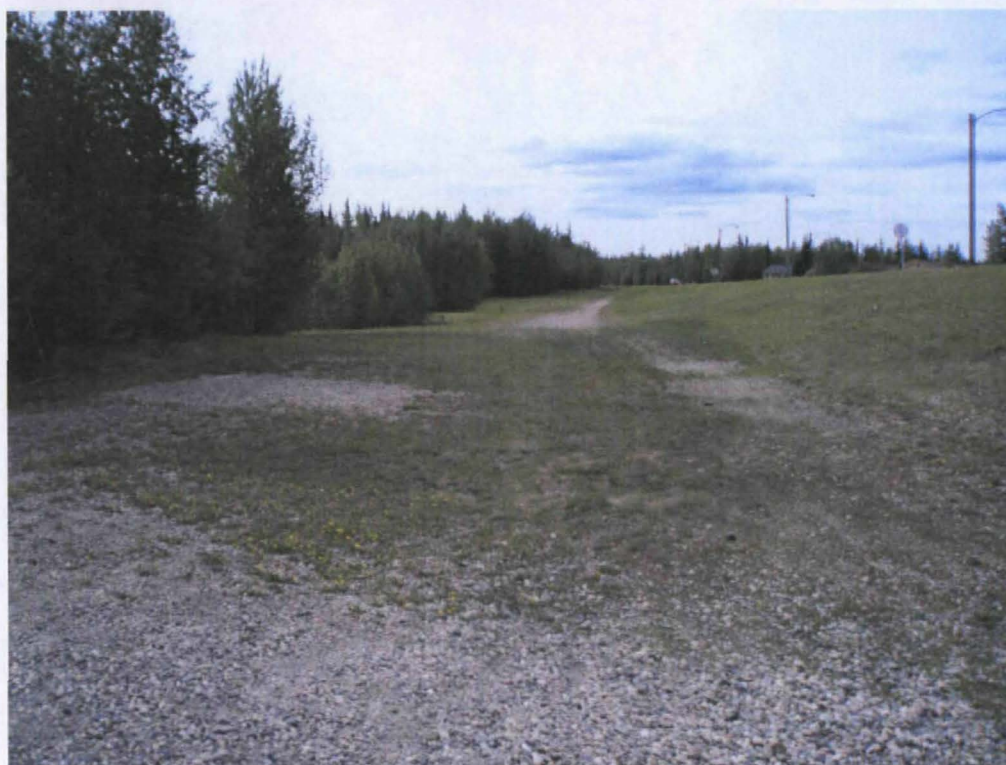
The 801 Drum Burial Site was inspected on June 6, 2006. All wells appeared to be in good condition at that time. The community information sign was also in good condition, and no unusual conditions were observed.

**Photograph 6 – 801 Drum Site Area
Operable Unit 1**

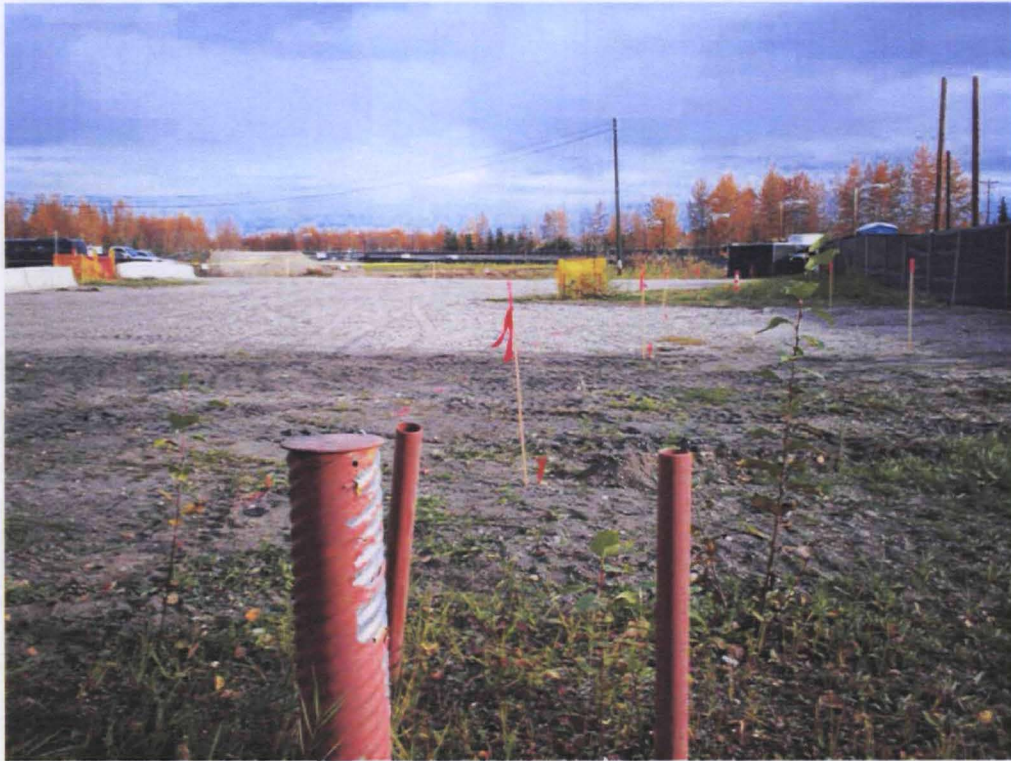
Photograph 9 – Former Building 1168 Area Showing Construction Activity (Monitoring Well AP-6809 in Foreground), Operable Unit 2

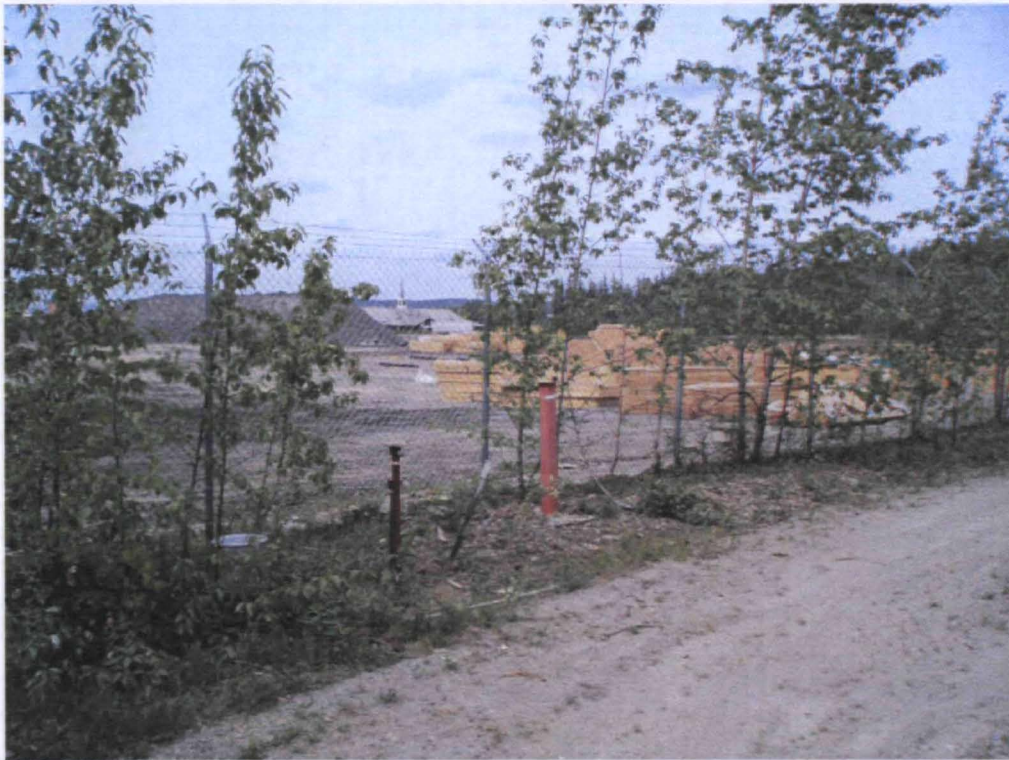
Photograph 15 – Post Fence Line along Thaw Channel Area (New Housing Development Construction in Background), Operable Unit 3

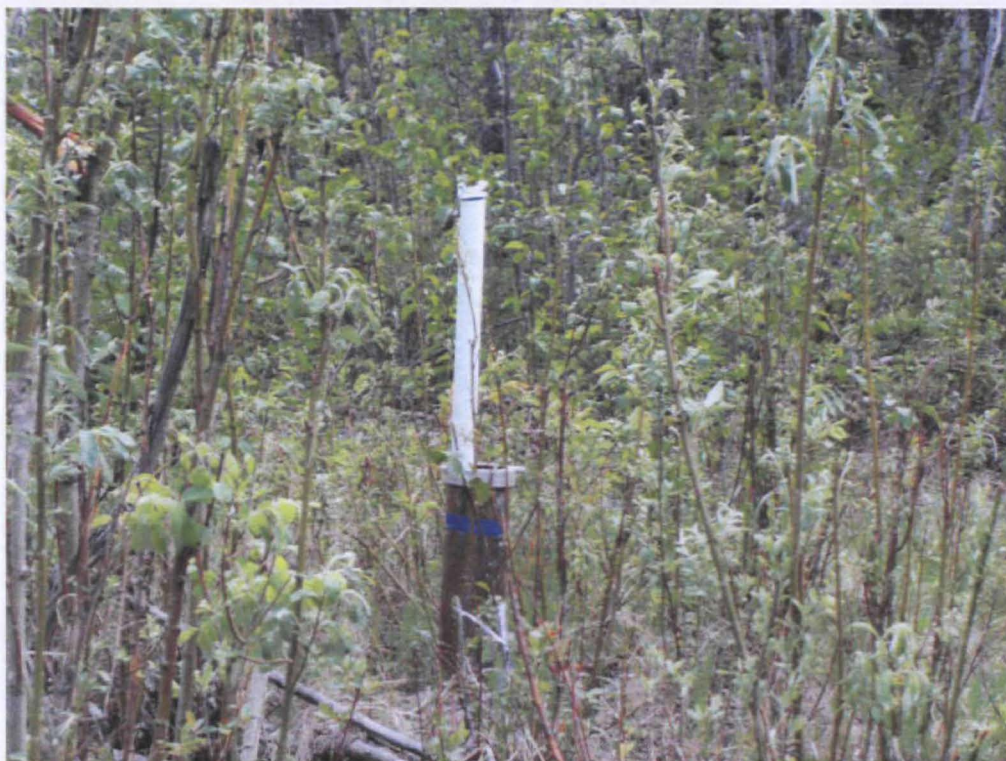
**Photograph 20 – Typical Frostjacking of Monitoring Well at Milepost 2.7 & 3.0 Areas
Operable Unit 3**
